# Manhole Inspection Summary

Manhole # S21A\_\_044MH

Insp Date: **9/18/07 6:32 AM**

**Location** Address: **1614 EDMONDSON AVE**

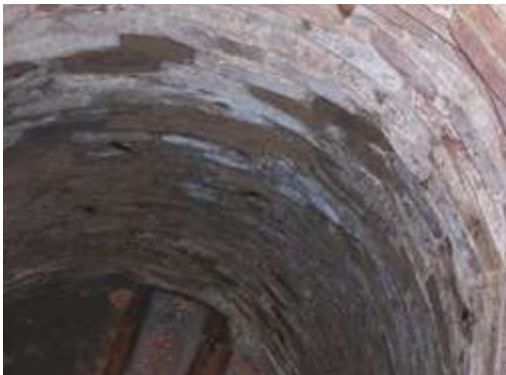
Defect 4

Infiltration: ☐ None ☐ Joint ☐ Cracks ☐ Mortar ☐ Roots ☒ **Wall**

BARREL INFILTRATION

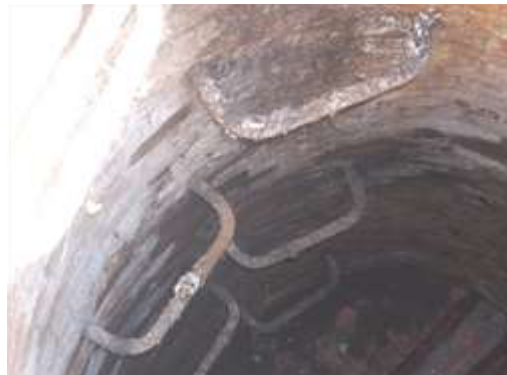
Defect 3

Count: **6** Missing: **0** ☒ **Corroded**

CORRODED STEPS

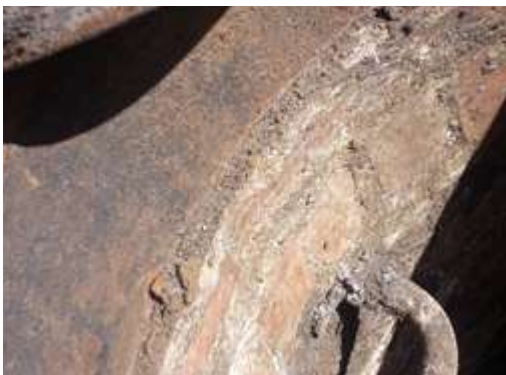
Defect 2

deteriorated chimney

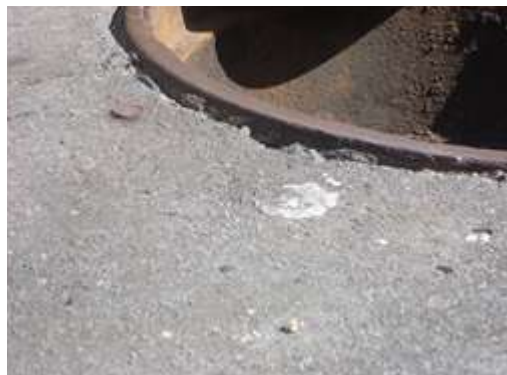
Defect 1

Offset: **0.5** (in.)

FRAME OFFSET

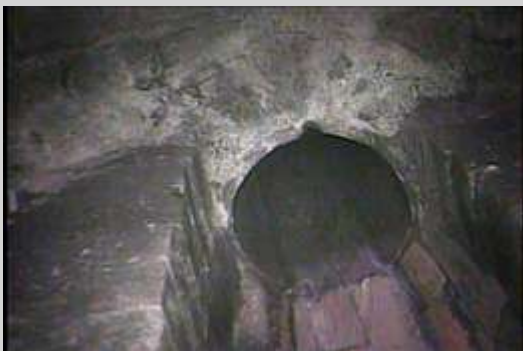
6 O'Clock Inflow

Pipe Height: **8.4** (in.) Rod and Bar (Angled)  
Pipe Material: **Clay** ☐ Pipe Lined  
Invert Depth: **9.63** (ft.) Flow Characteristics: **Slow**  
Deposits: ☒ None ☐ Mud ☐ Sludge ☐ Debris ☐ Grease  
Silt Depth: (in.) Deposits Extent:  
Infiltration: **None** Pipe Seal Cond: **Broken**
